## Inspection Report

123 Perfect Place

**Inspection date:** 3/16/2013

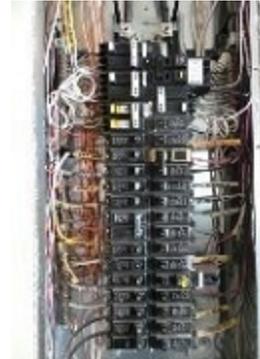
## Service panel interior

Wires that are labeled as GFI are going into normal 20 amp breakers. Recommend replacing these breakers with ground fault interrupt breakers as soon as possible because these service the master bedroom bathroom jet tub and the kitchen outlets .

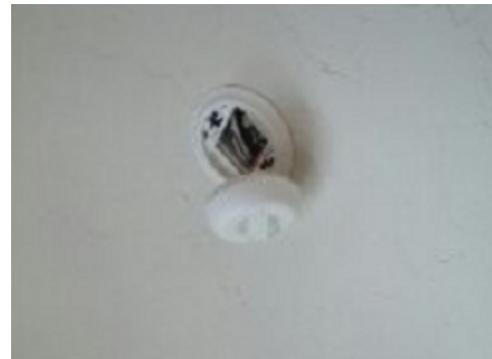
## Smoke detectors/ CO

Living room smoke detector is hanging loose, unable to test. No CO detectors found.

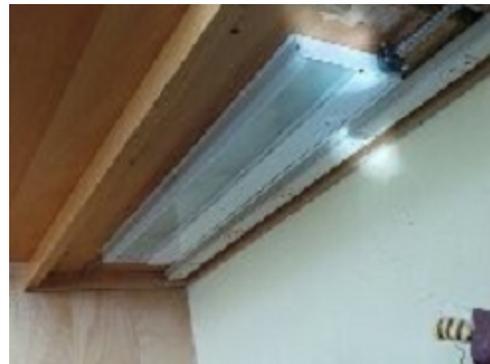
## Wall outlets/ GFI

Kitchen outlets are under the cabinets and no GFI outlets were found. Service panel has GFIs for bedrooms but do not have GFI for jet tub in the master bedroom bathroom or the kitchen outlets .

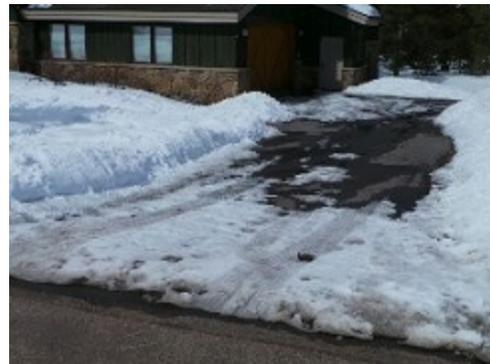
## Driveway

Snow packed and unable to inspect . Driveway has a gentle slope towards the house with a 90 degree left turn into a 2 car garage.

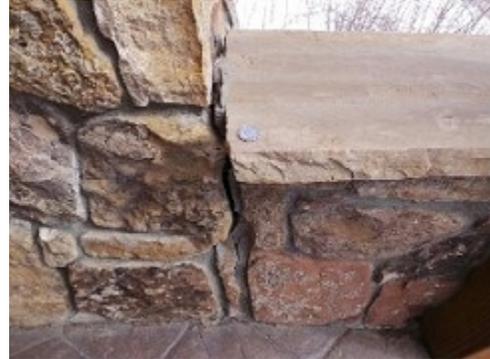
## Front steps

A crack is on both sides of the front steps that continues across the landing. Recommend filling with grout to prevent further damage and to stabilize.

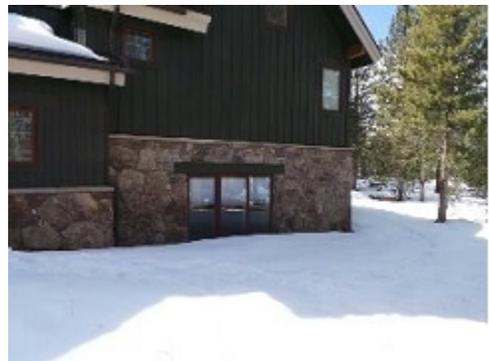
## Retaining wall

The retaining wall creates a patio area in the back of the house accessible by the basement back door. I did not find any stairs out to the backyard as the retaining wall was mostly snow covered.

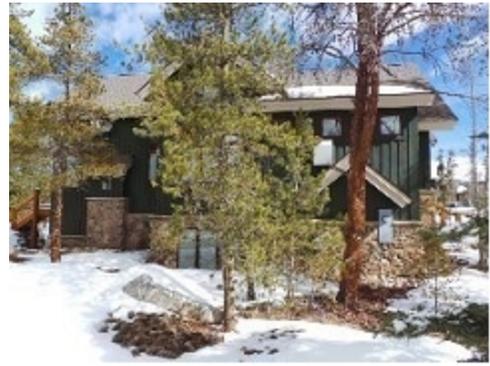
## Side 1 of house

Side 1 of the house or the south side or the left side has a few dead tree limbs hanging over the roof of the house and should be trimmed back.

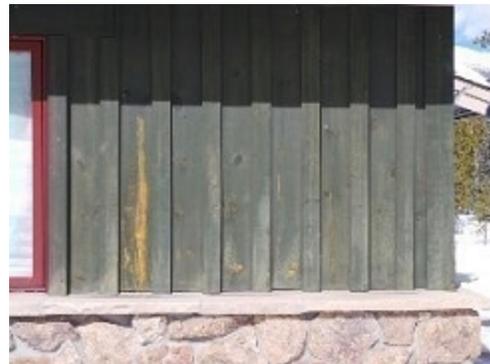
## Siding

Wood siding with a few areas where the sap has bled through the stain. The back Southwest gable has two bird made holes just under the eaves.

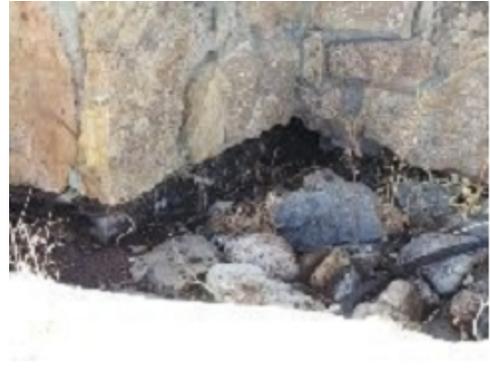
## Soil contact

Several areas around the base of the house where the foundation and stone meet the ground is exposed and may collect water and ice. I recommend filling these exposed areas with stone.

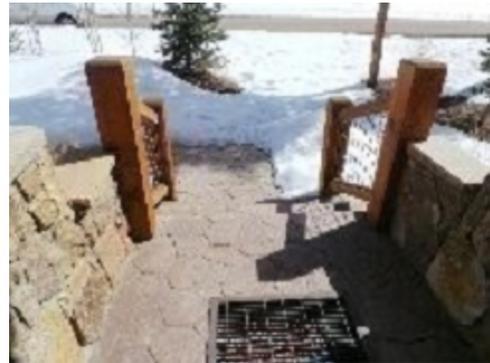
## Observed settling

The stairs leading up to the front door have settled leaving up to a half inch crack completely through. Recommend grouting and sealing to prevent further damage.

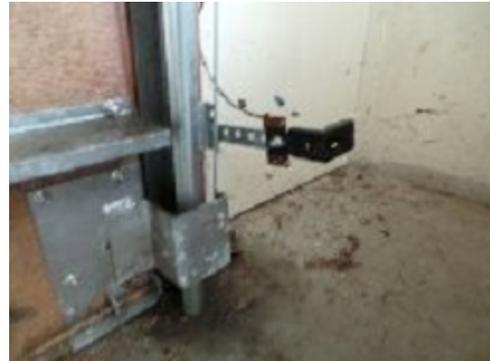
## Door sensor

Tested and works. Exposed wires.

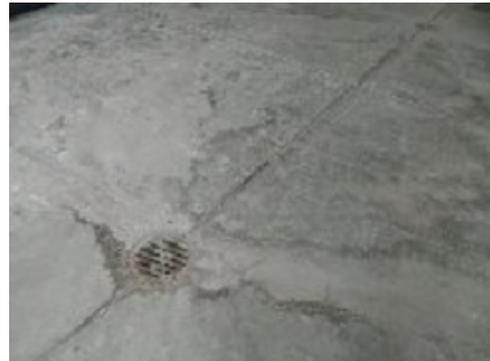
## Garage floor

Double floor drains. Minimal hairline cracks.

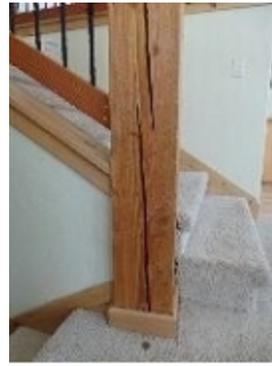
## Post and beams

Post show normal cracking and slight twisting. Air see all of beams to ceiling look good.

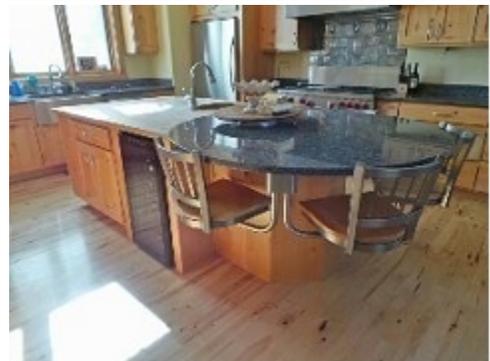
## Island

Countertop is granite and wood. Has 4 attached swing out chairs and a built in wine cooler that does not turn on. Recommend repair or replacement of wine cooler.

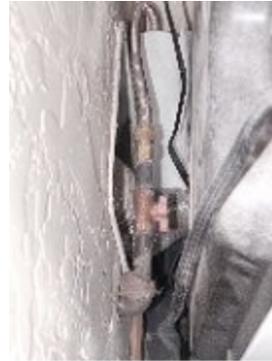
## Dryer vent

Dryer vent needs to be cleaned at the dryer source and where it exits the building . Flex tubing may be going into the wall and if it is, should be replaced with a standard hard wall tube. This is also the location of the gas shut off switch behind the dryer.

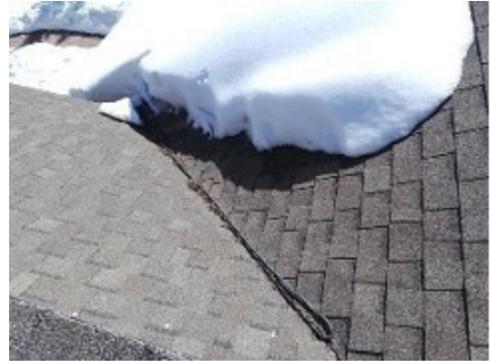
## De-icing

Many of the valleys and eaves have de-icing equipment. Because the roof was partly snow packed I was unable to inspect the roof completely.

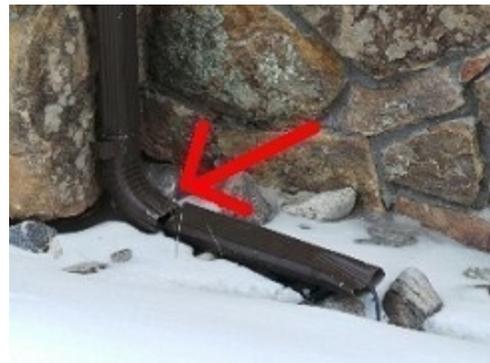
## Downspouts

Downspout extension is disconnected. Recommend repair.

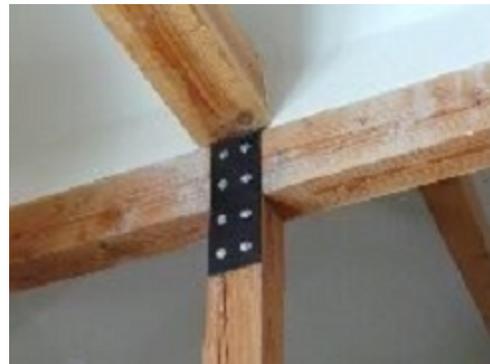
## Interior water damage

Beams show signs of previous water damage. Recommend sealing the above roof valley.

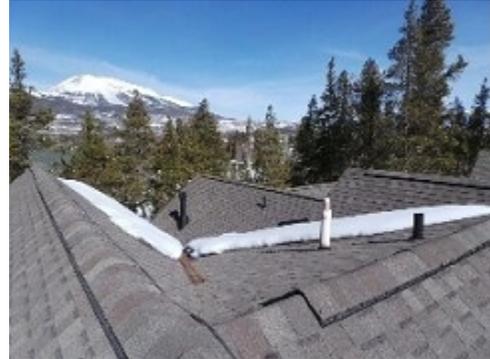
## Roof type

This house has a complicated roofing system with several areas where snow collects. There were a few minor torn shingles observed.
