## Inspection Report

123 Perfect Place

**Inspection date:** 3/16/2013

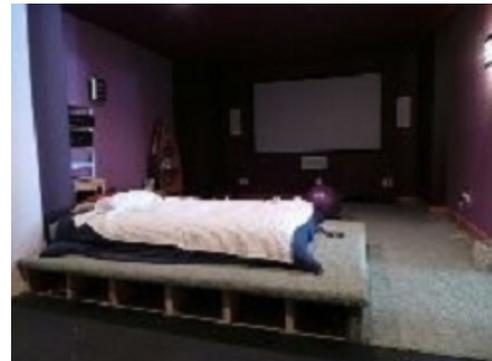
### Theater room

Theater room being used as a guest bedroom.

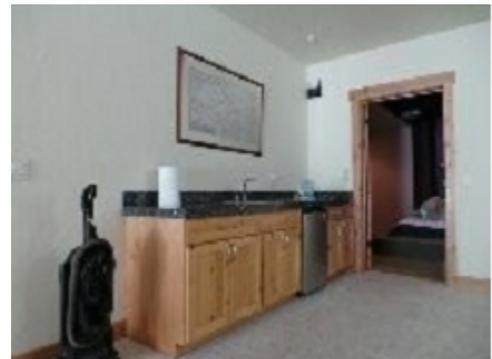
### Walls

basement is fully furnished and includes a butlerd pantry and refrigerator.

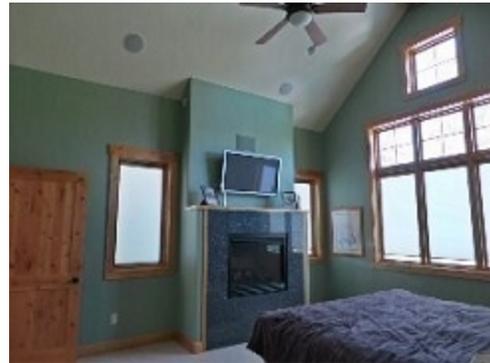
## Bedroom master

The fireplace was operated.

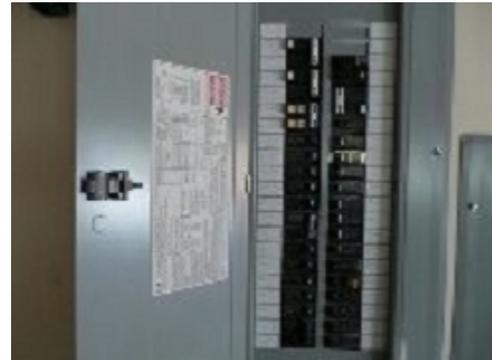
Cutler-hammer 225 amp. Disconnect is outside by the service entrance on the left or southside of the house.

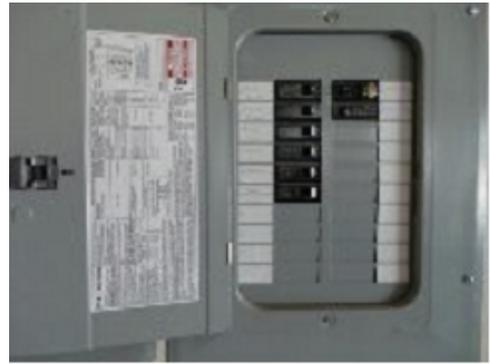
Cutler-hammer 125 amps.

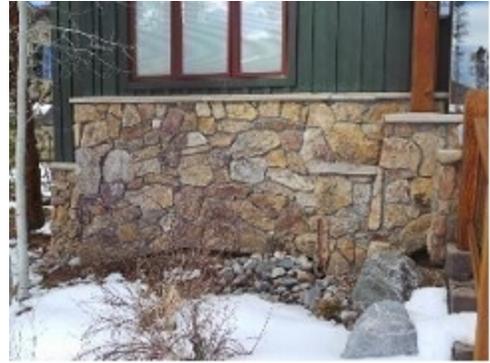
Base of entire house is wrapped with stone.

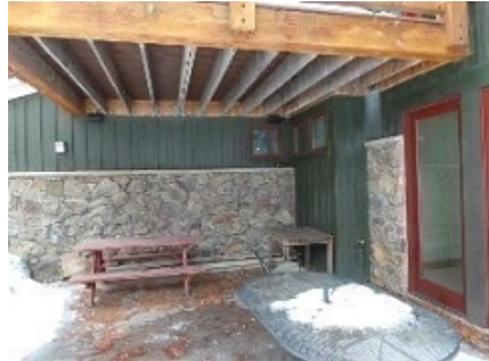
## Patio

The patio surface is formed colored concrete similar to the front walkway.

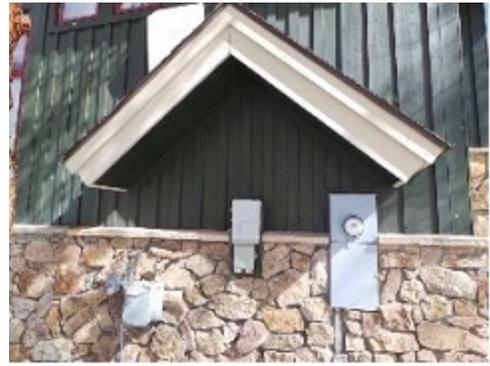
## Utility entrance

Utility entrance is on the south or left side of the house with its own roof.

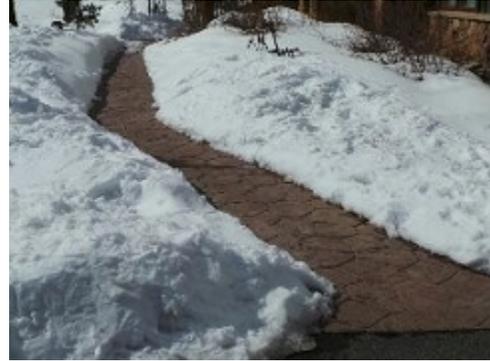
## Walkway

Walkway is made from formed and colored concrete.

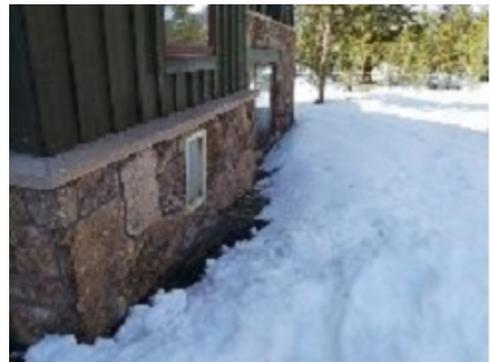
Basement type foundation.

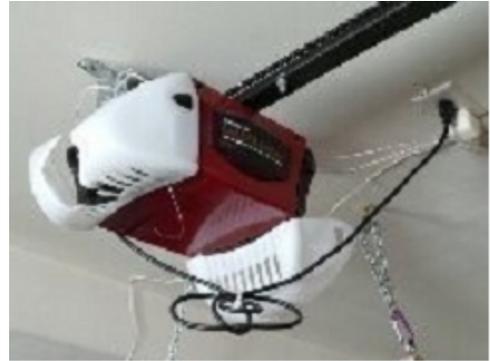
## Door opener

Liftmaster professional 3 quarter horsepower

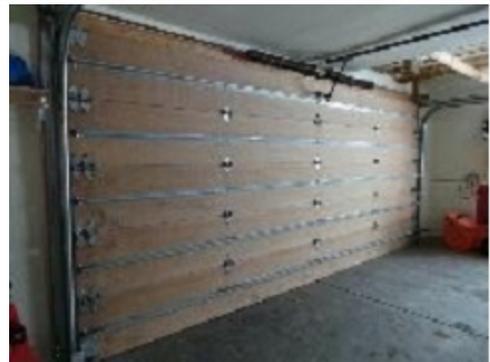
1 inch solid wood twould car single door.

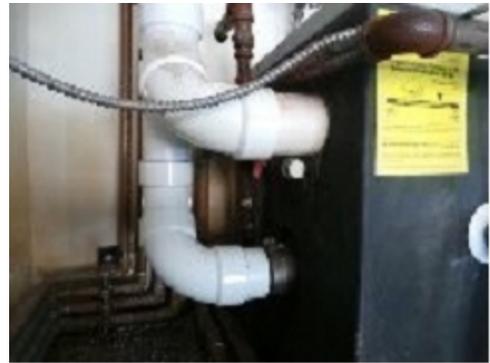
## Combustion air

Sealed system .

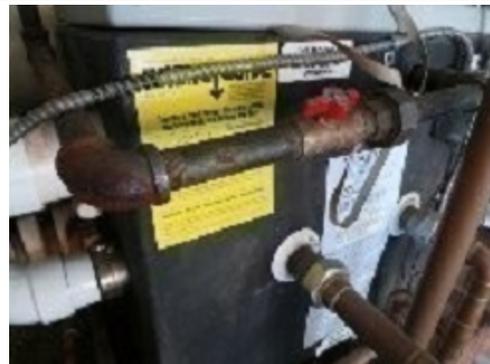
## Fuel/ shutoff

Natural gas.

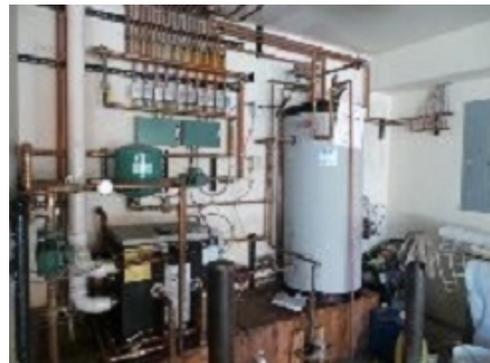
## Heating type

Infloor radiant heat 10 zones. Munchkins 299m.

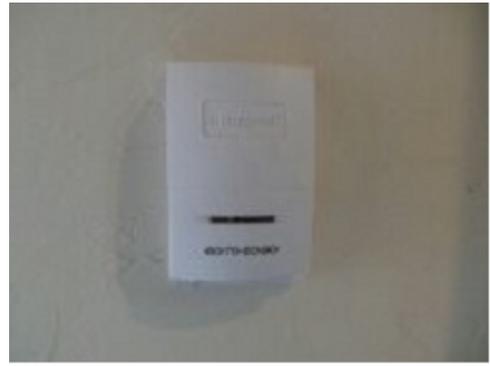
Honeywell manual thermostats .

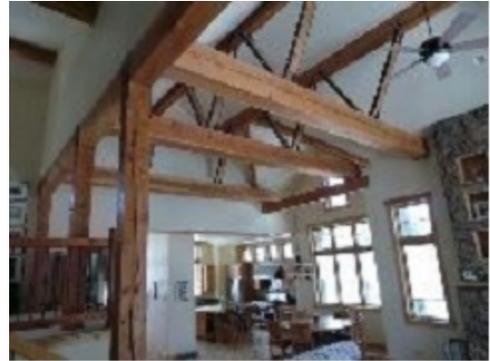
## Ceiling

1 foot square beams with. 8 inch square posts.

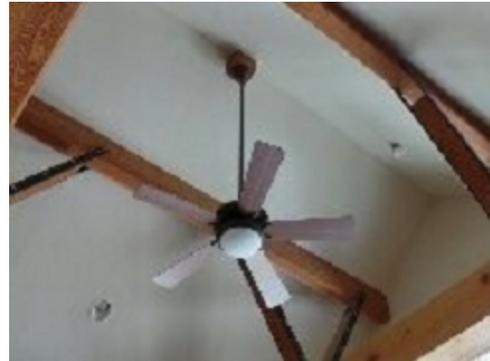
## Ceiling fan

Good-Inspected

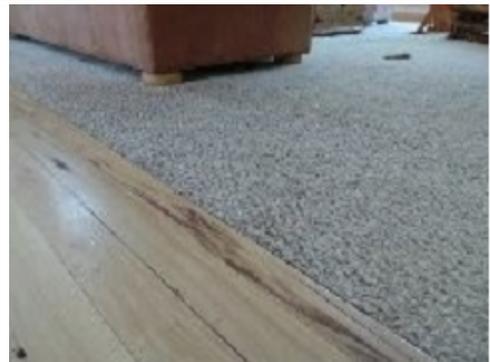
Hardwood floors and wall to wall carpeting.

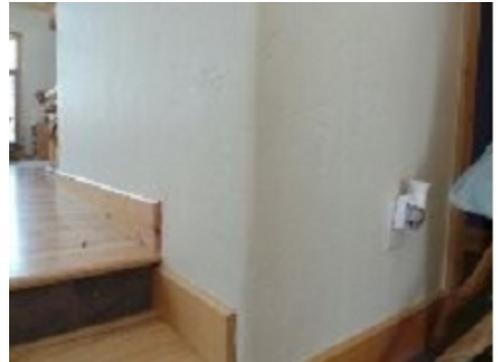
## Walls

Stucco plaster walls with bull nose corners.

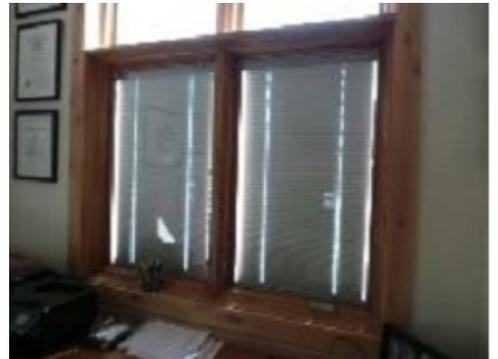
## Windows

Triple pane solid wood with built in shade

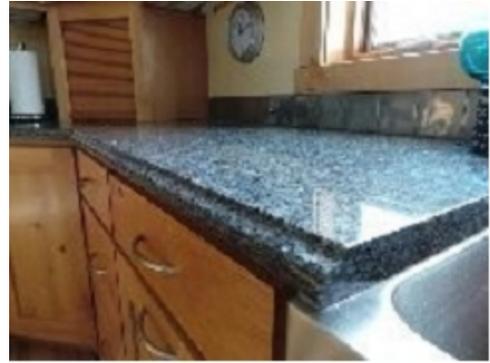
## Counters

Great blue beveled granite countertops

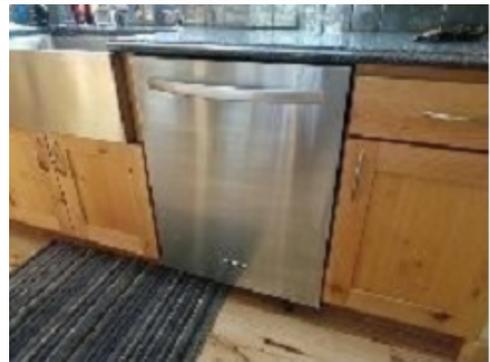
## Dishwasher

Kitchenaid k u d l 15 f x s s e

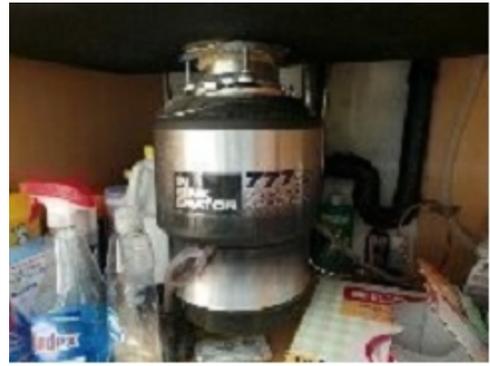
## Disposal

Insinkerator 777ss

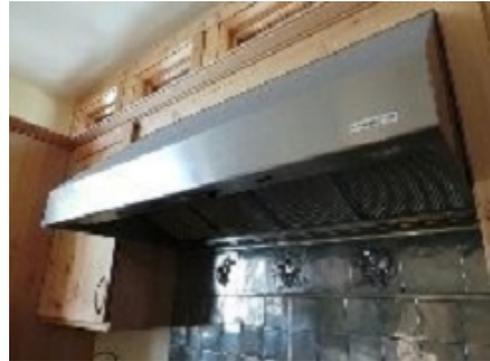
## Exhaust vent

range master by broan nutone

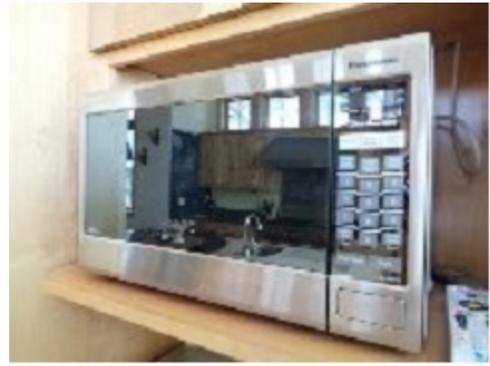
Panasonic 1200 watt. Model number nn-sn671s

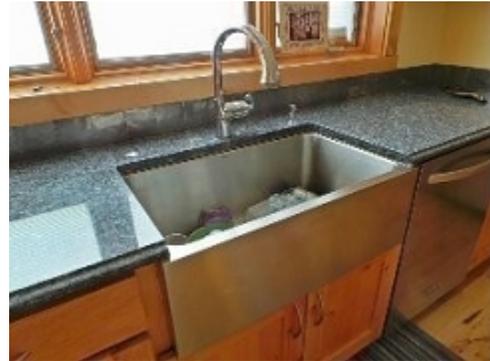
## Sink

Black granite sync with grohe faucet

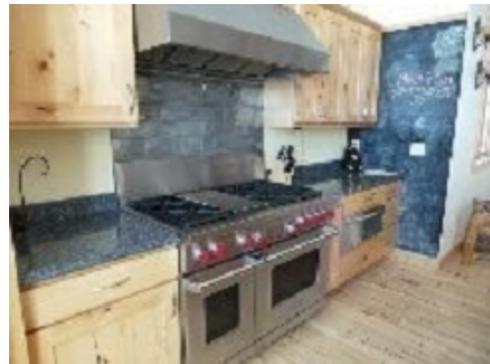
## Stove and oven

Wolf 6 burner range double oven

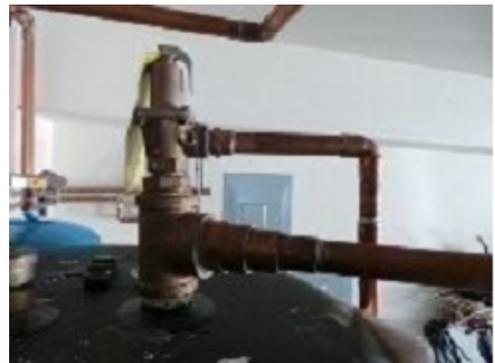
## PR valve and drain

Drain is just below in garage floor and boiler has its own pressure relief valve. As well as this 1 on top of the hot water container .

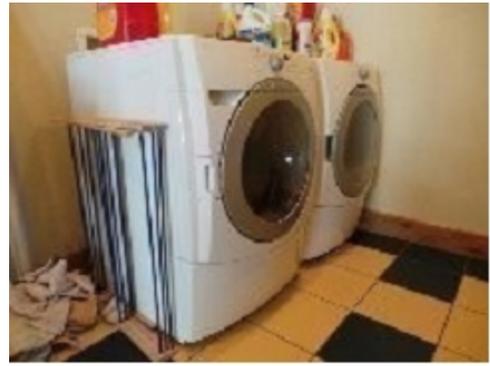
## Washer/ Dryer

Kitchenaid washer dryer khws01pwjd and ugh301kwh1

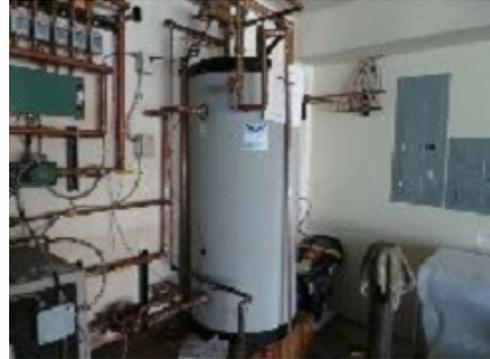
## Water heater

Smart triangle tube hot water side arm holding tank from boiler.
